Manhole Inspection Summary

Manhole # S15MM1015MH

Insp Date: **12/5/06 10:54 AM**

Location Address: **4571 THE STRAND**

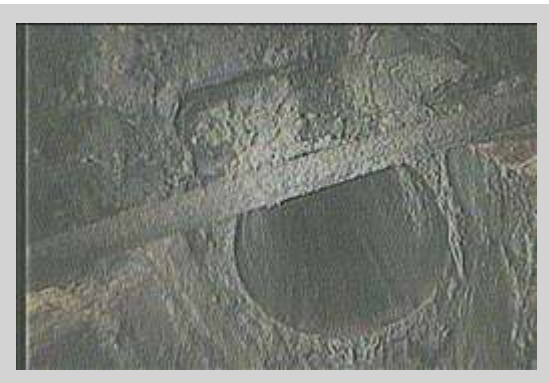
8 in. Circular Gravity Sewer Pipe In @ 4 O'Clock

Pipe Material: **Clay** ☐ Pipe Lined

Invert Depth: **11.45** (ft.) Flow Characteristics: **Slow**

Infiltration: **None** Pipe Seal Cond: **Unknown**

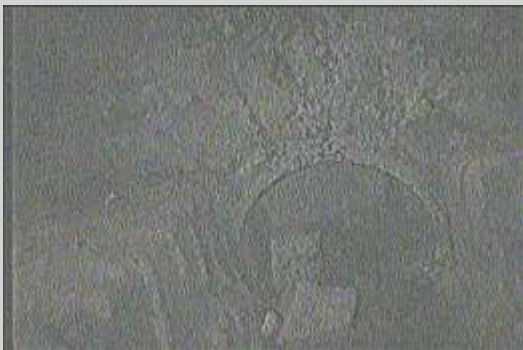
Pipe In @ 8 O'Clock

Pipe Material: **Clay** ☐ Pipe Lined

Infiltration: **None** Pipe Seal Cond: **Unknown**
